Amendment 39-17121; AD 2012-14-07]

Airworthiness Directives; Bell Helicopter Textron Canada Helicopters

ACTION: Final rule; request for comments.

2012-14-07 **BELL HELICOPTER TEXTRON CANADA HELICOPTERS:**

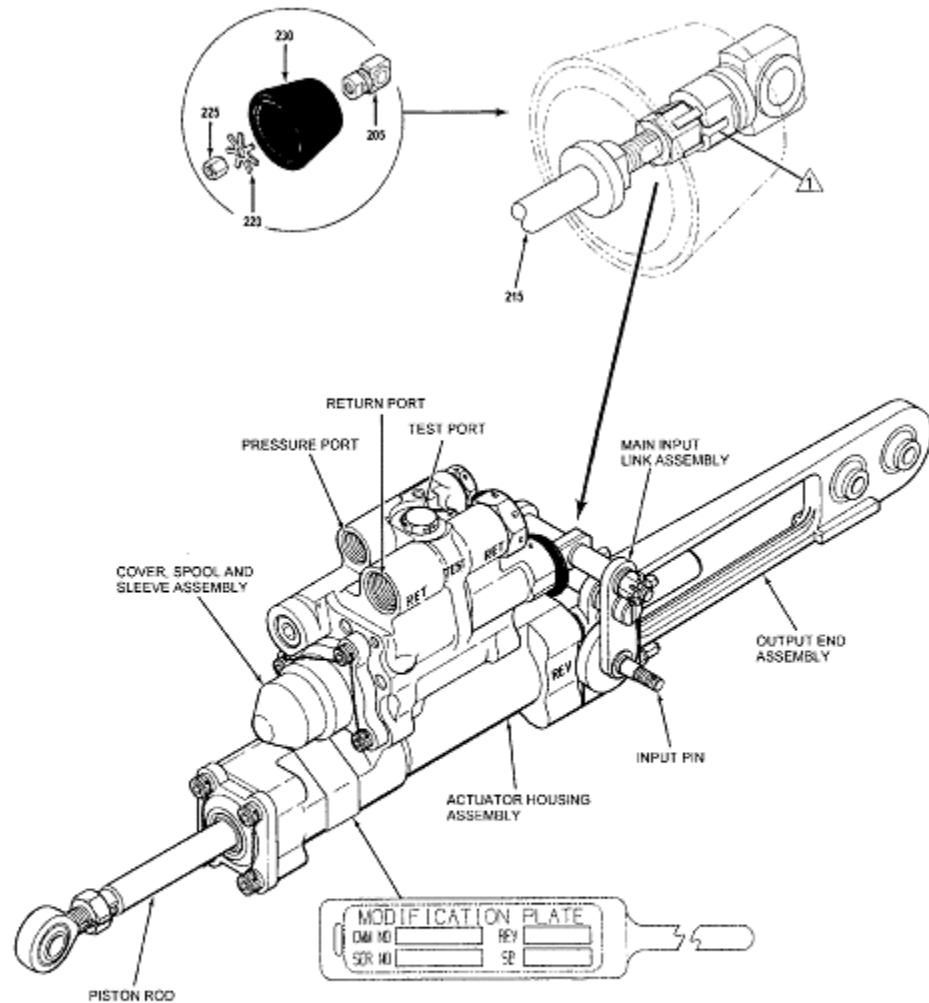
This AD defines the unsafe condition as a loose or misaligned part in the servo that could lead to failure of the servo and subsequent loss of helicopter control.

A MINIMUM OF ONE TAB SHALL BE IN LINE AND BENT FLUSH WITH THE NUT FLAT SURFACE AND A MINIMUM OF ONE TAB SHALL BE IN LINE AND BENT FLUSH WITH THE CLEVIS ASSEMBLY FLAT SURFACE

- (i) Retract the boot depicted as 230 in Figure 1 to Paragraph (f) of this AD.

(ii) Applying only hand pressure, determine whether the nut, the shaft, or the clevis assembly, depicted as items 225, 215 and 205, respectively, in Figure 1 to Paragraph (f) of this AD, turn independently. If the shaft turns independently of the nut or clevis assembly, before further flight, replace the servo with an airworthy servo.

(iii) If the shaft does not turn independently, inspect to determine if at least one tab of the lock washer is bent flush against a flat surface of the nut and if at least one tab of the lock washer is bent flush against a flat surface of the clevis assembly.

(iv) If at least one lock washer tab is not aligned and bent flush with a nut flat surface and at least one lock washer tab is not aligned and bent flush with a flat surface of the clevis assembly, before further flight, replace the servo with an airworthy servo.

(v) If any tab of the lock washer is not bent flush against either a flat surface of the nut or clevis assembly, bend the tab flush against a flat surface.

(2) After accomplishing paragraphs (f)(1)(i) through (f)(1)(v), vibro-etch the letter “V” at the end of the part number on the data plate.
